# **On Water Supply System in Ancient Armenia**

Aminia Kanetsyan

National University of Architecture and Construction of Armenia, 105 Teryan Street, Yerevan, Republic of Armenia

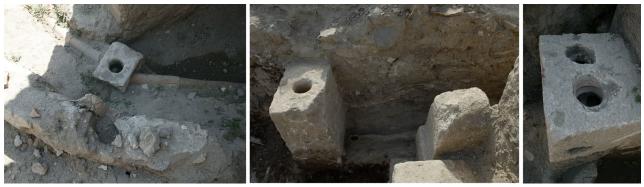
Fig. 10. Water parting stones of Artashat

Excavations discovered water parting nodes in various rooms of the bath as well as under its outer southern wall. They are made from well-worked limestone blocks, many of which have been recycled. About ten such stones were found (Fig. 10).

All these blocks have different sizes  $(0.58 \times 0.57 m, 0.50 \times 0.52 m, 0.40 \times 0.50 m, 0.25 \times 0.30 m, 0.25 \times 0.25 m, \text{etc.})$ . In the round holes of these stones, broken-off clay pipes are preserved. At the outer corner wall of the cool hall (tepidarium) of the bath, a complex node was excavated in situ, consisting of three water parting stones located at different depths and having round holes at

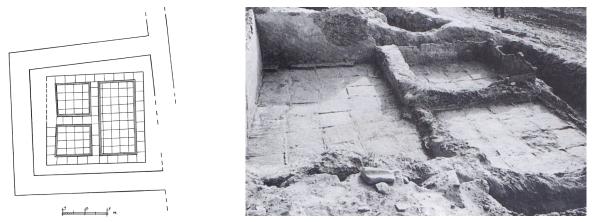
Fig. 21. Plan of the water reservoir in Artashat

The water supply facilities also include a water reservoir discovered in ancient Artashat on the eighth hill, built into a rectangular room [11]. The preserved height of the walls is 1 m, the thickness of the walls of the reservoir is 0.30 m. In this structure, the water-tightness of the walls is solved in a very peculiar and interesting way (Fig. 21, 22).

The walls themselves were made of adobe bricks, which were the basis for a waterproof lime layer. Studies have shown that this layer was applied in two steps. The first layer with a thickness of 1.20 cm was applied to the smooth surface of the adobe brick, after which reed rods were placed vertically at different intervals from 1.20 to 0.60 cm. After this layer was dried, a second layer 2.80 cm thick was applied, forming a monolith of concrete with a total of 4.00 cm thick.

The arrangement of the water reservoir floor is also interesting. Although it was dismantled, it is easy to restore its picture from the ceramic tiles and other remains preserved near the walls. The leveled surface was covered with lime mortar. On it were laid out well-fired square bricks  $(0.37 \times 0.37 m)$  with a thickness of 0.05 m. The surface of these tiles was also covered with lime mortar of 1-2 cm thick.

The total area of the water reservoir is 12.95 square meters, the entire reservoir is divided by partitions into three parts, one of which is half the area, and the other two are almost equal. It is possible that from above these compartments were connected to each other by means of pottery water pipes, which were found to have collapsed into the pool. The presence of water pipes, double walls (walls of rooms and a pool) with hydraulic properties, which contributed to the preservation of cold and clean water, apparently indicates that this reservoir served as a cistern for drinking water. At the same time, in its shape and size, this basin resembles the fish-salting baths of the Northern Black Sea region [12]. The proximity of the Araks River suggests that the Artashat basin could well have served fish and salting purposes, but there is no evidence of this assumption. According to archaeological material, as well as stratigraphy, the basin dates back to the 1st century AD, as well as the fish-salting baths of the Northern Black Sea region.

Reed bars, apparently, ensured the resistance of the first layer, playing at the same time the constructive role of the reinforcement of all concrete, while not undergoing mechanical and hydrothermal deformation (due to the very low water resistance). The reed has decayed and vertical holes with traces of reed remained in the places of the twigs. Reed reinforcement simultaneously reduced the consumption of concrete, facilitated the physical and mechanical impact on the base, and added strength to the structure. The composition of the concrete ensured the water tightness of the pool. Here, as in all hydraulic coatings, there is a mixture of lime and crushed bricks.
